Hringsdalur, Arnarlax hf.
B-bottom survey,
November 2019
(maximum biomass survey)

Information client			
Titel	Hringsdalur, Arnarlax hf. B-bottom pre-survey, November 2019		
Report number	APN-61656.B01		
Site name	Hringsdalur	Coordinates site	65°44.350 N 023°46.179 V
County	Vestur Barðastrandasýsla	Municipality	Vesturbyggð
MTB-or estimated max biomass	4981 tonn	Site manager/contact	Silja Baldvinsdóttir
Client name	Arnarlax hf.

Results from B-survey iht. NS 9410:2016 (main results)			
Parameters and indexes		Parameters and site status	
Gr. II. pH/Eh	1,00	Gr. II. pH/Eh	1
Gr. III. Sensory	0,81	Gr. III. Sensory	1
GR. II + III	0,91	GR. II+ III	1
Date field work	19.11 2019	Date report	03.01.20
Site status (NS 9410:2016):			1

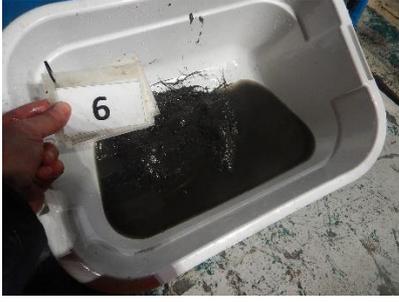
<i>St 6</i>

A white plastic tray containing a dark, silty sediment sample. A hand holds a white label with the number '6' next to the sample.

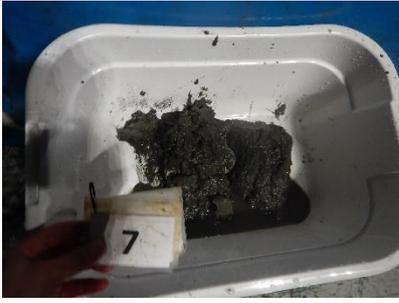
A white plastic tray containing a dark, silty sediment sample. A hand holds a white label with the number '7' next to the sample.

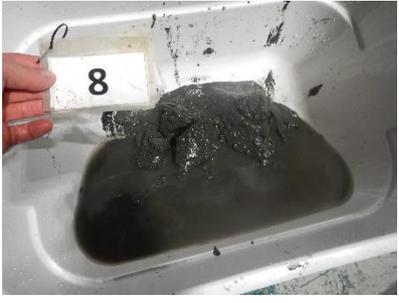
A white plastic tray containing a dark, silty sediment sample. A hand holds a white label with the number '8' next to the sample.

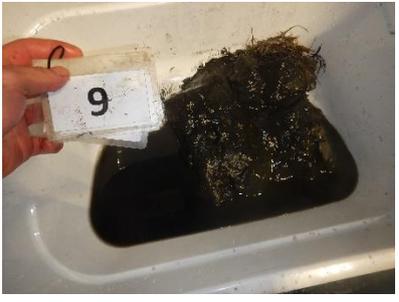
A white plastic tray containing a dark, silty sediment sample with some organic material. A hand holds a white label with the number '9' next to the sample.

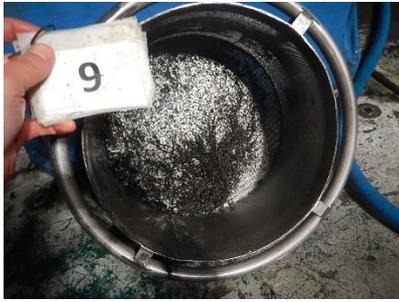
A stainless steel sieve containing the residue from sample 9. A hand holds a white label with the number '9' next to the sieve.

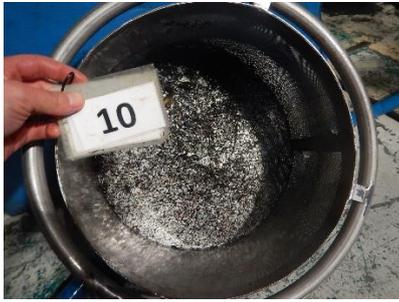
A stainless steel sieve containing the residue from sample 10. A hand holds a white label with the number '10' next to the sieve.
