Sandeyri West, Arctic Sea Farm B-bottom survey, September 2021 (pre study)

Akvaplan-niva AS: APN 63467.B01

Information client			
Title	Sandeyri West, Arctic Sea Farm. B-bottom survey (pre study), September 2021		
Report number	APN-63467.B01		
Site name	Sandeyri West	Coordinates site	66°08,684N 022°52,027V
County	Ísafjarðarsýsla	Municipality	Ísafjarðarbær
MTB-or estimated max biomass	5.500 tonnes	Site manager/contact	Steinunn Guðný Einarsdóttir
Client name	Arctic Sea Farm

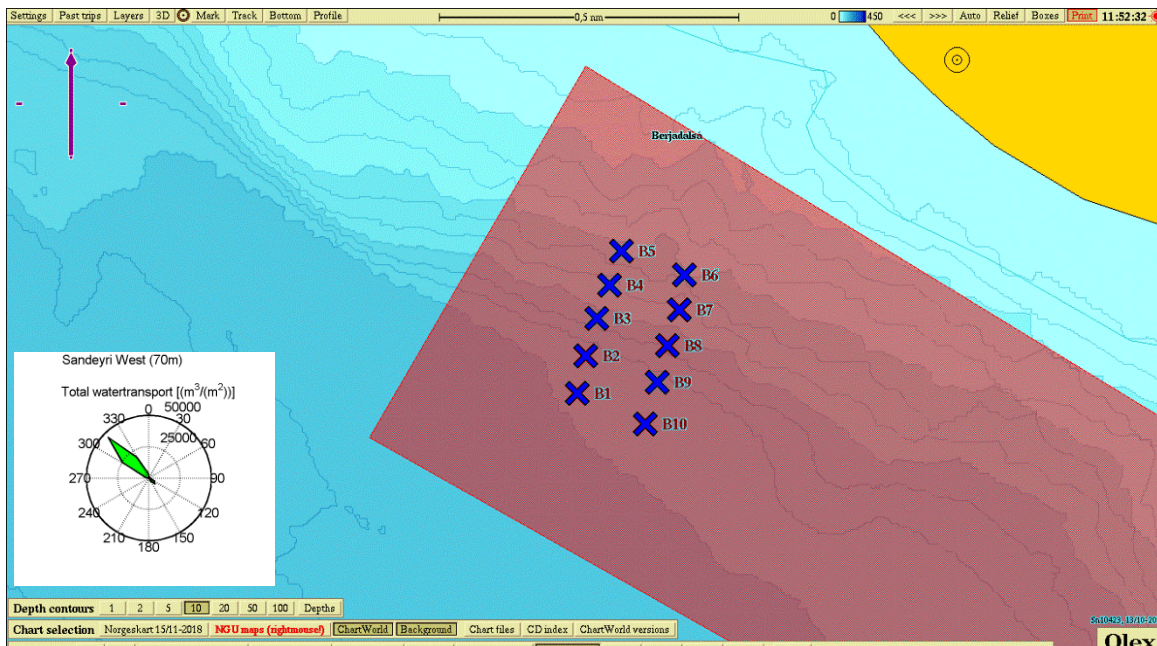
Position of the 10 stations in the survey is given in Figure 2 and Table 2. Positioning of the stations was chosen based on guidance and criteria described in NS 9410:2016 and spread around the periphery of the cages (as cage setup is planned). At the site the typical depth in the local impact zone is in the range from 40 – 120 m, with an increasing depth on southern part of the mooring frame. The placement of sampling stations was chosen to give a good picture of the condition of the whole local impact zone. It is important to evaluate the status in both the deeper and shallower parts of the local impact zone of the fish farm. The sampling stations had a depth varying from 64 to 119 m. The placement of the sampling stations is regarded to be in accordance with the descriptions for survey of local impact zone given in NS 9410:2016.

Figure 2. Chart showing Sandeyri West site. Sampling stations st. 1 – 10 are marked with color codes that describe the group II and III condition according to NS 9410:2016, chapter 7.11. Color codes: Blue = very good condition, green = good condition, yellow = bad condition, red = very bad condition.

For the group II parameters (pH/Eh), all stations had conditions 1 «very good». For sensory parameters (group III) all ten stations had condition 1 «very good», see Table 1. For combined parameters II and III (pH/redox and sensory) all ten stations received status 1 «very good», see Figure 2. Animals were present in all the ten samples, polychaetes were most prominent, and molluscs were observed in 70% of samples.

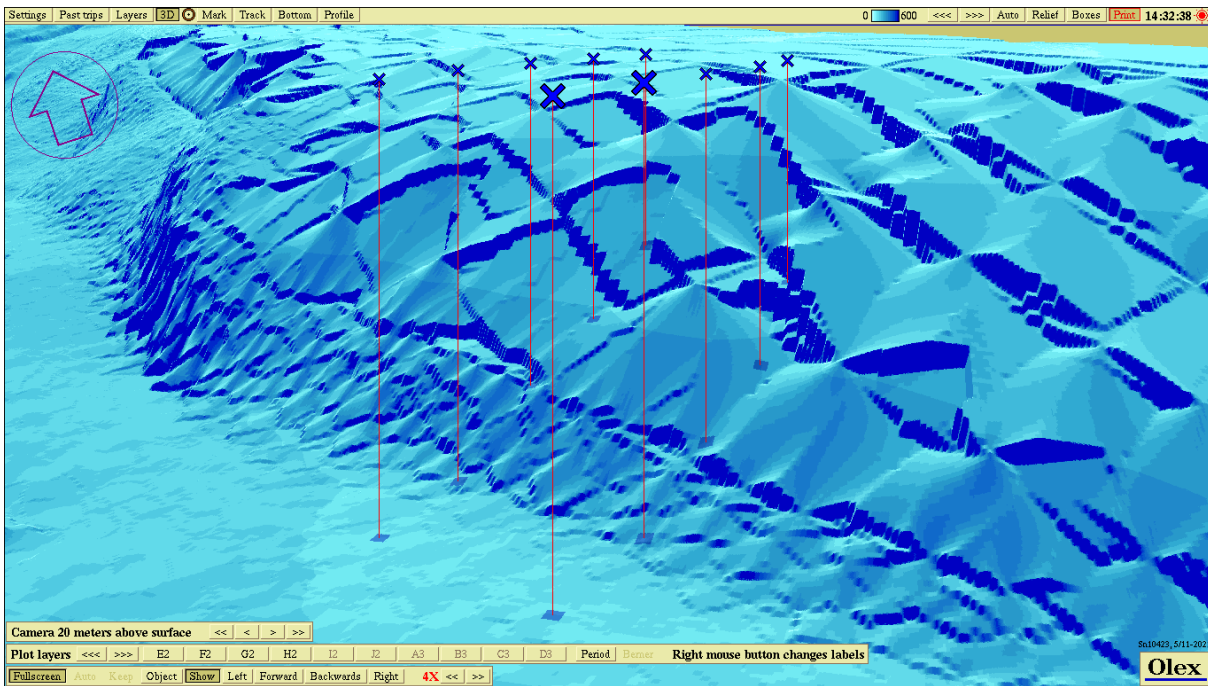
Figure 3. Showing bottom topography 3D at Sandeyri West with each sampling station according to info in Figure 1 and Table 2.
